## **DIY Rear Drive Rebuild for the BMW K1200LT**

The information in this document was collected from the BMW K1200LT user forum located at BMWIt.com.

### Another way to skin the cat?

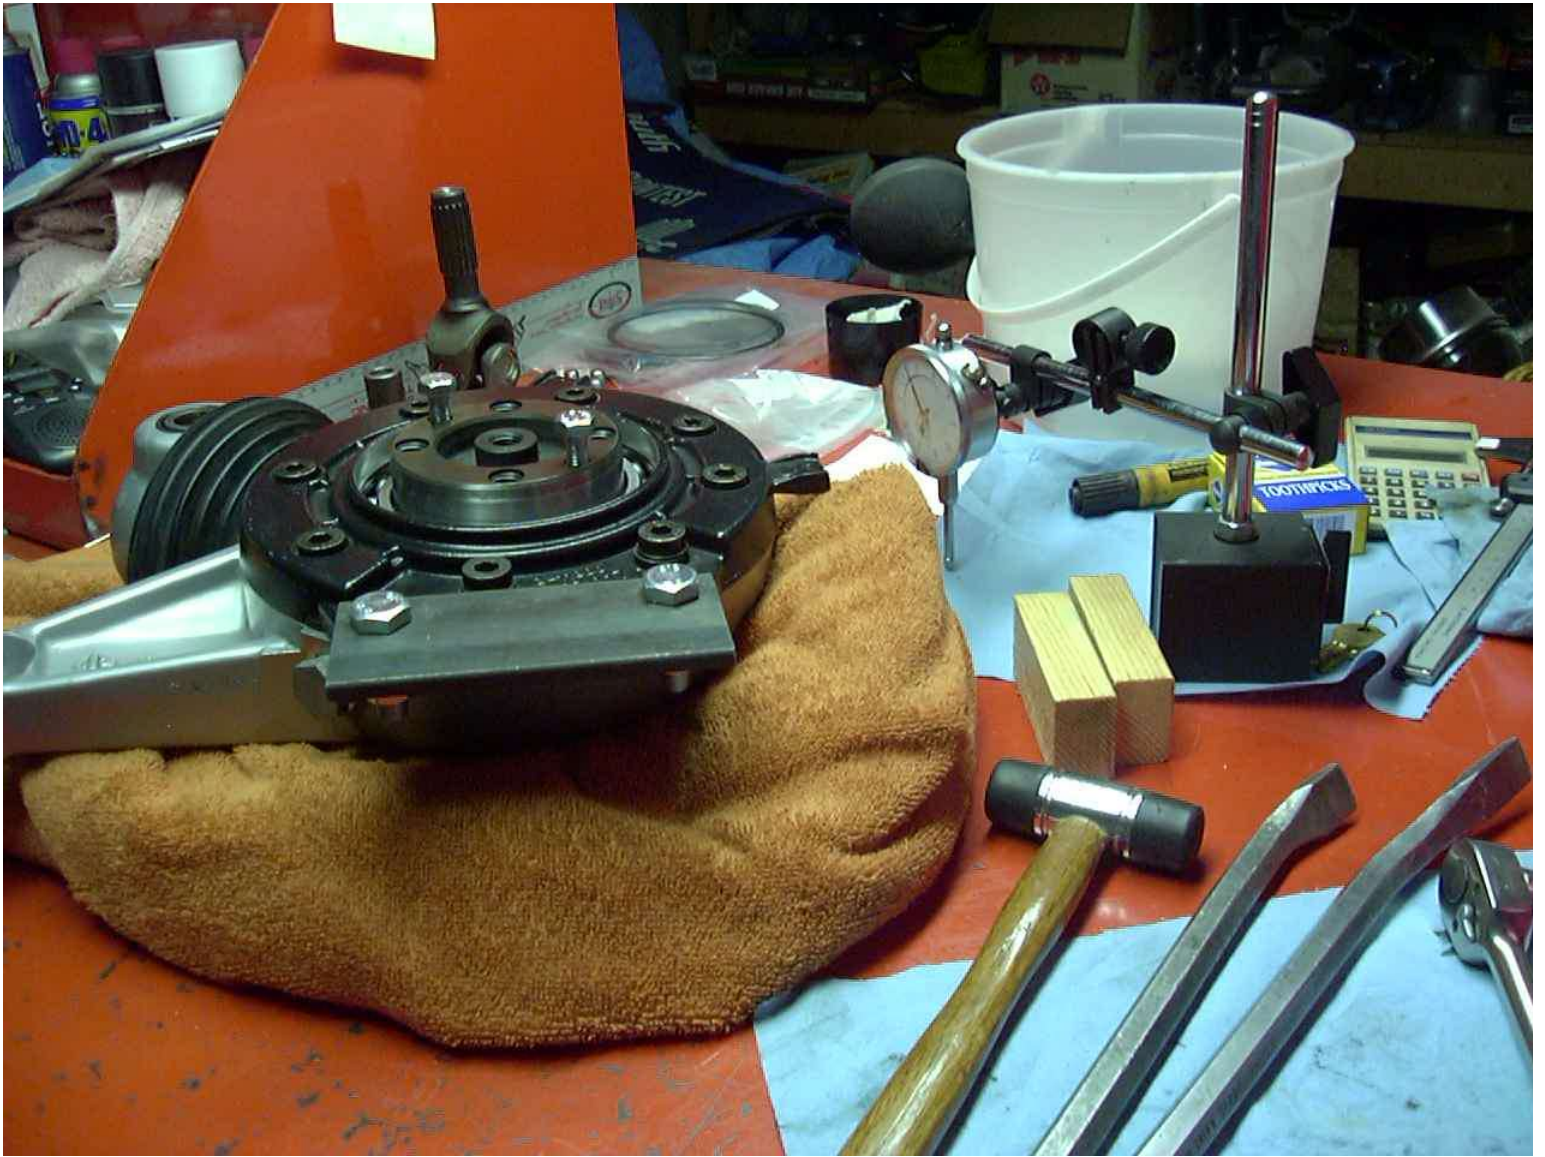
Let me explain:  
See Pic 1.

Tools: Dial indicator w/ magnetic base, two small pry bars, SMALL soft face hammer, two small wood blocks to use as pry points, and a heat gun and a non contact temp reading device (not shown)

Setup: Drive unit assembled without housing O ring, hub seal, and preload shim(s), with or without pinion installed, parts lightly oiled is OK but CLEAN, CLEAN, CLEAN! Flat piece of steel bolted to the caliper mount holes to land the magnetic base on, two bolts screwed into the hub to use as pry points. Optional: Large "old" bath towel to place the assembly on to protect the finish.

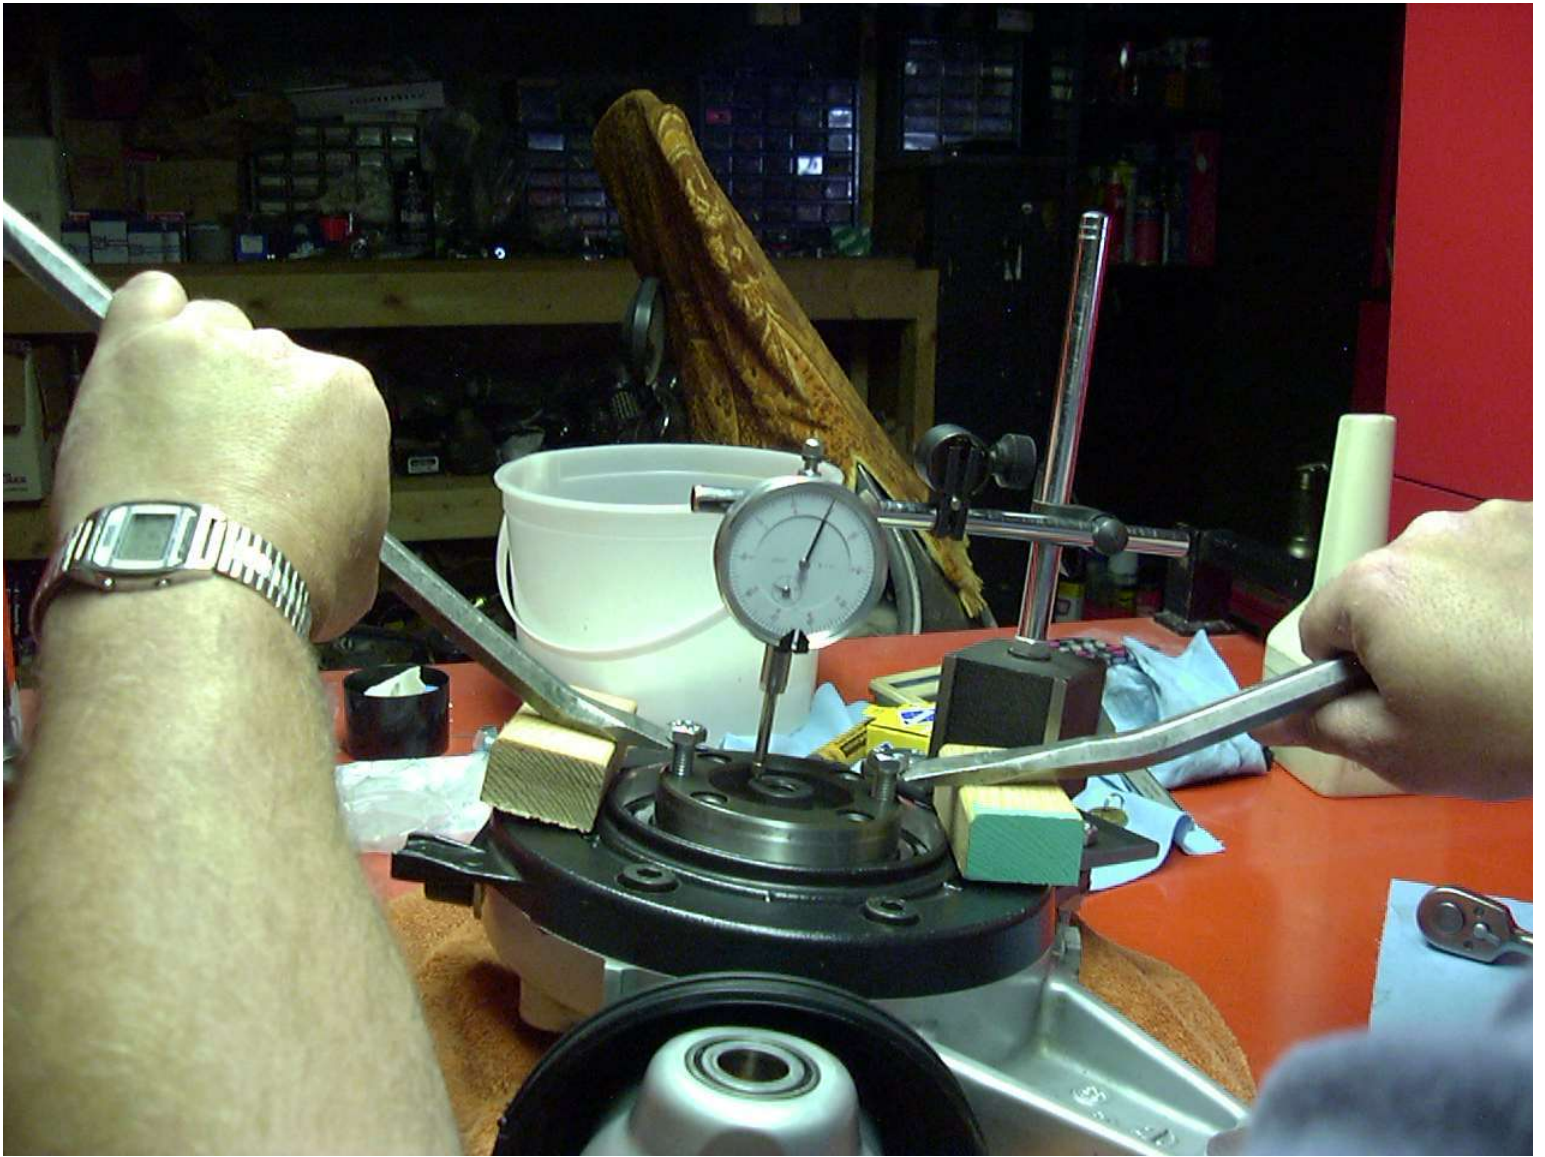
The Prep: On the three I have done I've found that it didn't require much heat on the housing cover to allow the bearing to slip in its bore. Above 105 deg. F seemed to be sufficient. YMMV. Warm the housing cover. Take your time. Too hot to touch is way too much. Just enough to allow the bearing to slip in the bore and then just a little more.

See Pic 2.

The Deed: Put the magnetic base on the bolted on platform, place the dial indicator spindle on the center of the hub. Pry the hub assembly up in the bore.  
1. Now take the SMALL soft faced hammer and "thump" the hub to seat it back down,  
2. zero the indicator and pry up again. Read the indicator.

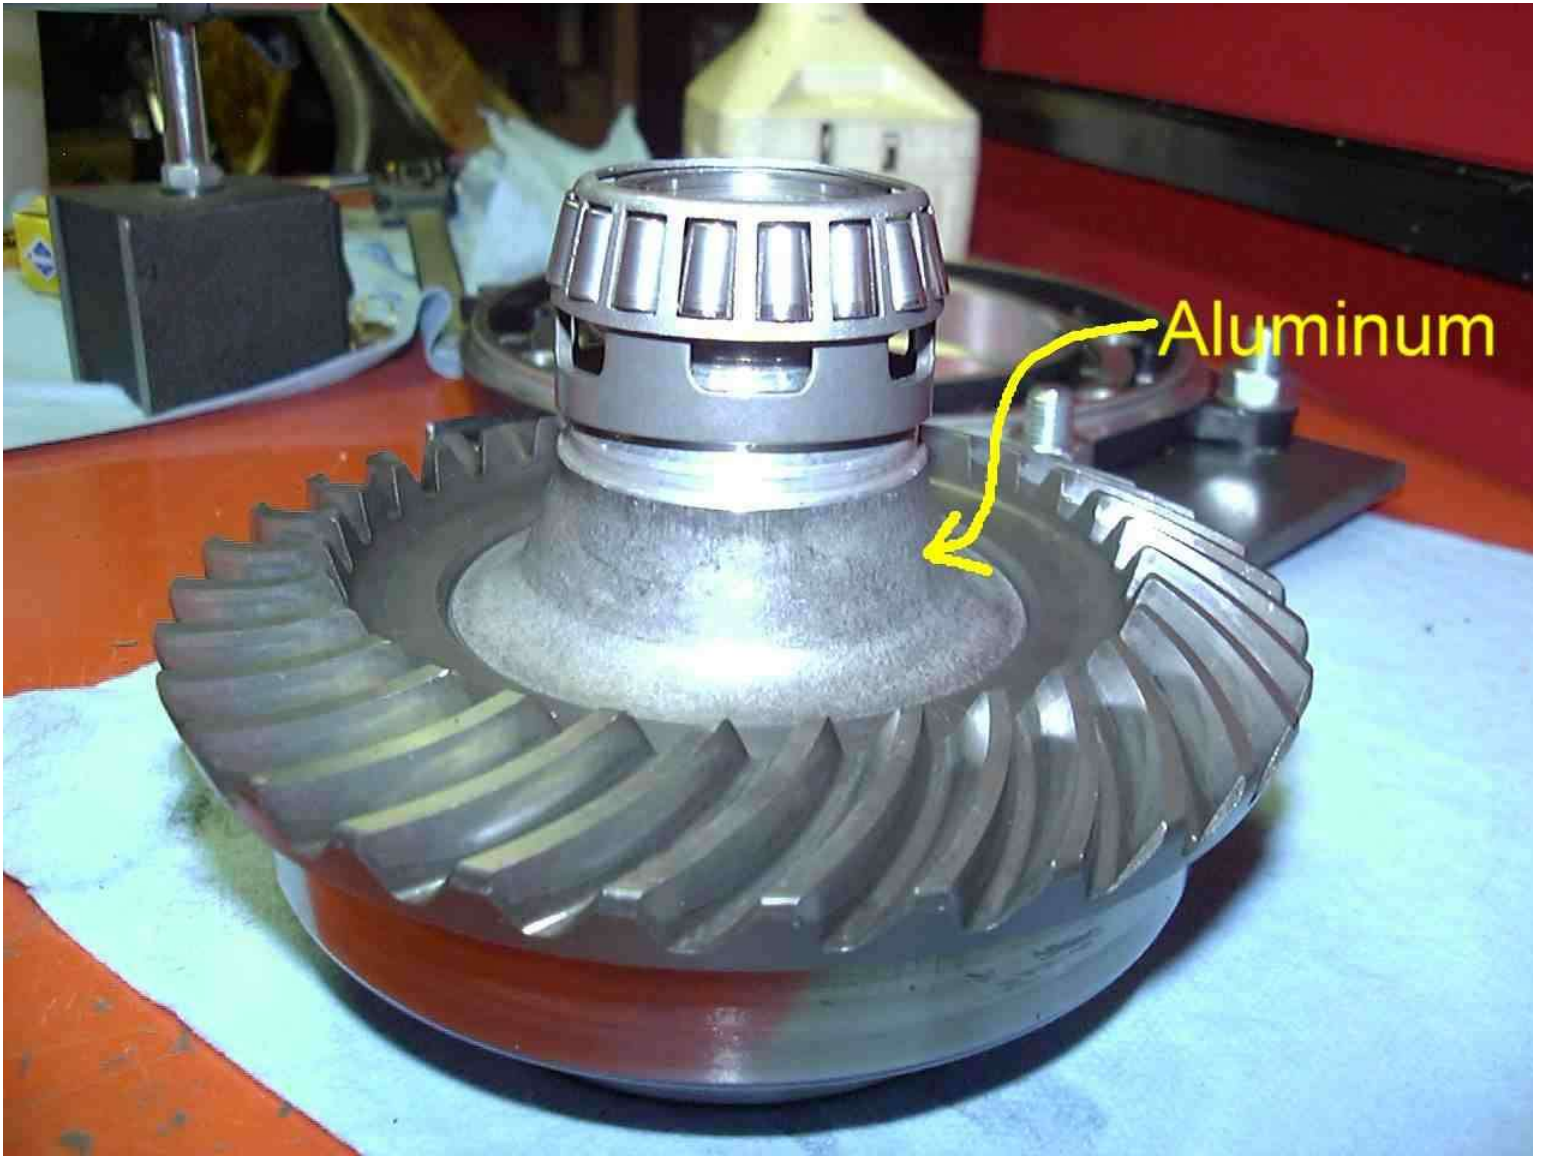
I think the reason for such a small change when heated is that the crown gear assembly is two pieces and one of them is aluminum (and expands more than if it were steel. (See Pic 3) The crown gear and hub are the same piece and made of steel.) The tapered roller bearing support (the cone shaped part) is made of said aluminum and is pressed into the hub portion of the crown gear as can be seen through the wheel bolt holes. (See pic 4)

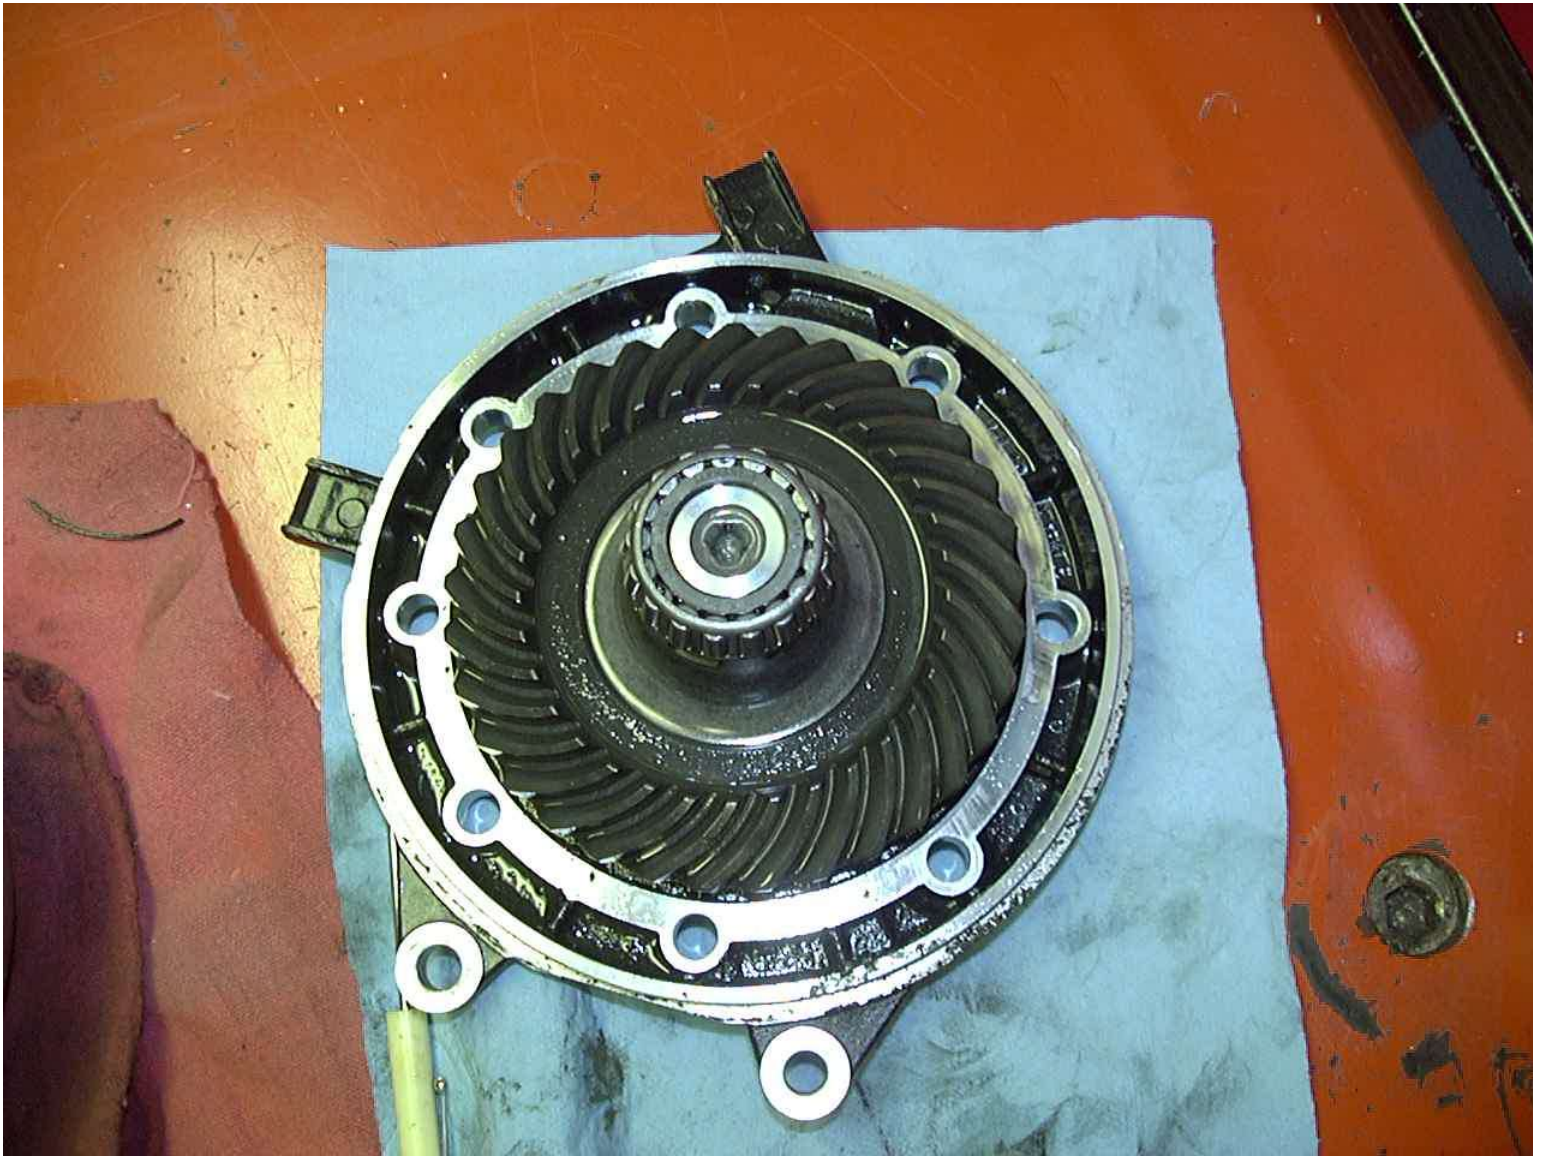
Pic 2. The face of the axle is faced (machined) except for the triangular shaped indent in the center which is raw cast.

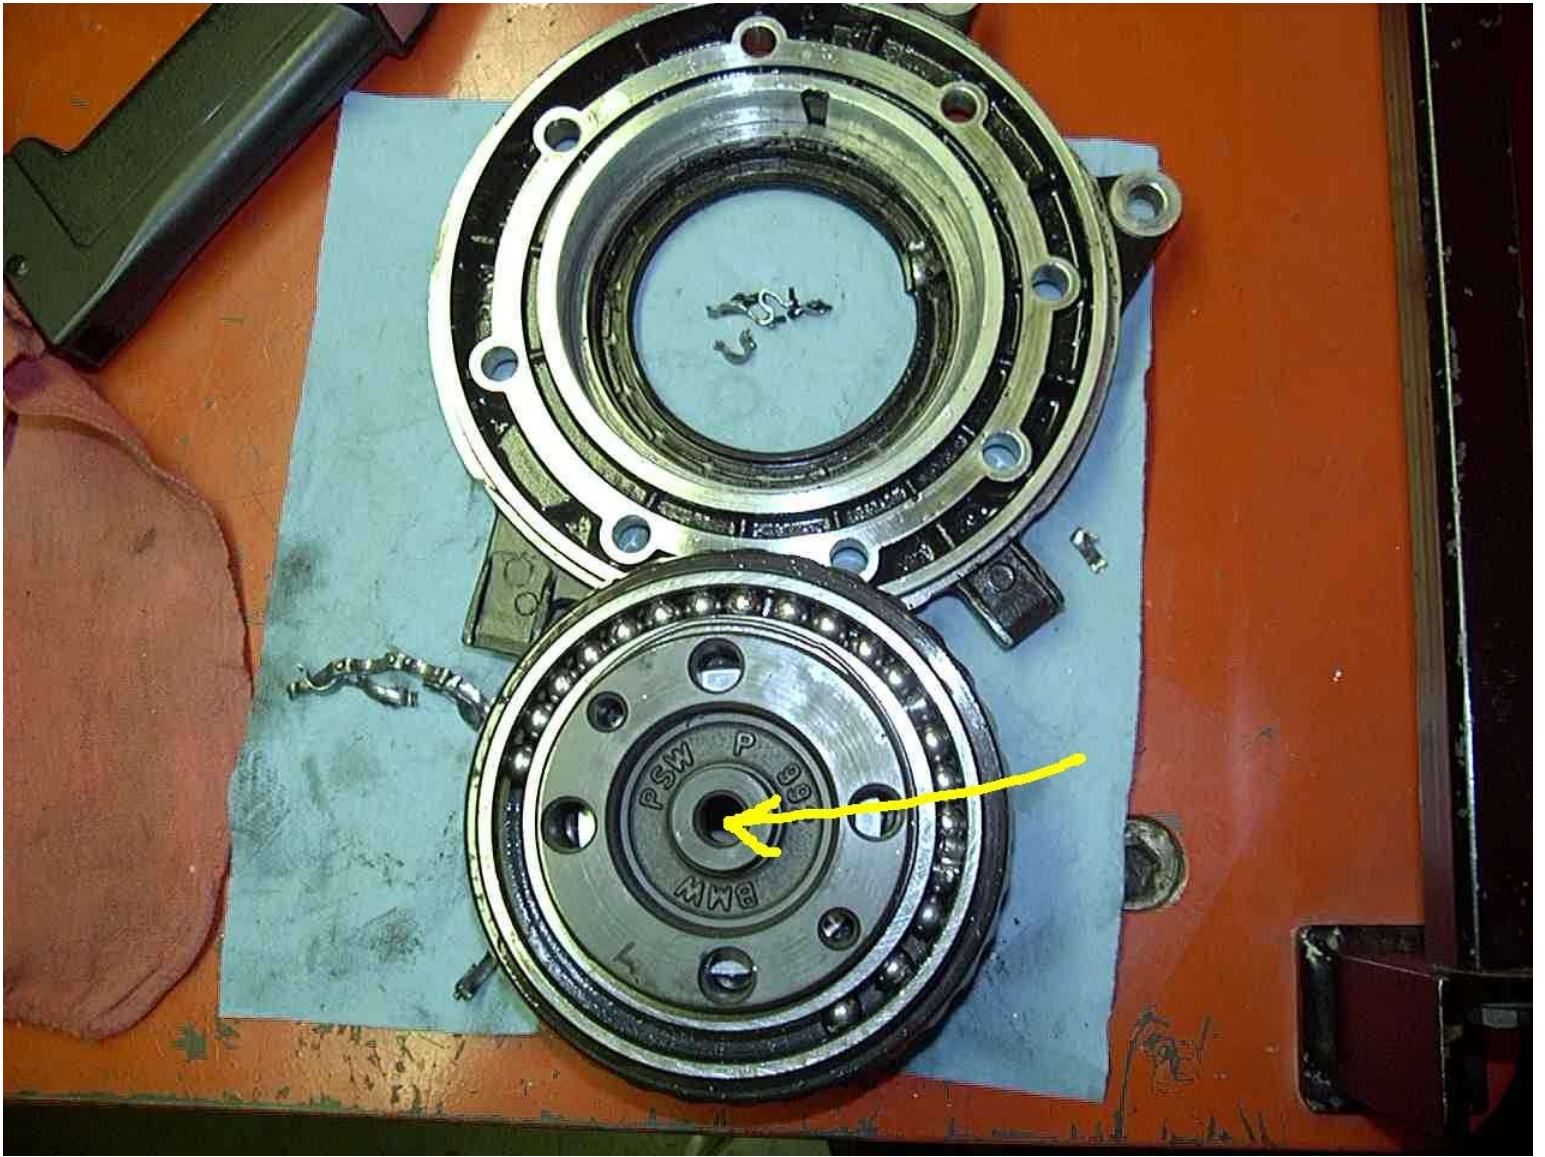
Pic 3. If you poke a screwdriver into the center hole of the wheel mount hub you will find a void to the bottom of the tapered bearing stub of the axle.

If you drop a magnet in there it doesn't stick to anything.

Look at this picture and understand why there is a warning in the service manual concerning the length of the wheel bolts. Can you imagine the preload problems you would have if you used too long a bolt and "jacked" the aluminum axle out of the crown gear hub!
